SELF PRIMING SERIES

Seal Repair for Encyclon Pump RP20-1BASHW

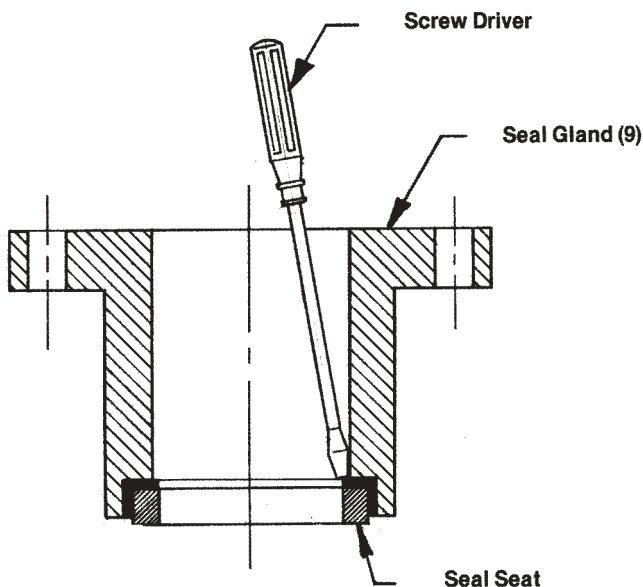
On pumps with mechanical seals remove spring from seal cavity after sliding impeller (12) off of shaft (1). Slide shaft sleeve (20) off shaft and remove seal head, inspect sleeve for wear and replace if necessary. Seal seat is located in seal gland (9) if cracked, damaged or worn out, replace. To remove seat from gland insert a screw driver from flanged end of gland as shown in Fig. 9 and tap seal seat out. Clean stuffing box and seal gland (9) thoroughly before re-assembly. To install new seat, oil rubber cup with clean oil and push seat into gland by hand being sure seat is pressed all the way down against the shoulder in the gland. If seat is not square against the gland shoulder the seal will leak and there will be uneven wear on the faces. Install new seal gland gasket (29) and carefully slide seal gland (9) over shaft (1) so as not to hit seat on shaft. Mount stem plate (14) on stem (7) and securely tighten holding screws. Slide seal gland (9) into stem plate (14) and draw screws down tight. (Do not slide packing gland into stem plate (14) on packed pumps.)

Clean shaft sleeve (20) and oil thoroughly, slide seal head (rotating member) onto shaft sleeve by hand, starting at end without slot. Slide seal head onto shaft sleeve until it is flush with end of shaft sleeve. Install new shaft sleeve gasket (24). Slide shaft sleeve (20) onto shaft (1) gently allowing seal head to make contact with seal seat in seal capacity and then sliding sleeve to shaft shoulder, install seal spring. Slide impeller (12) onto shaft (1) and lock in place using retaining washer (18). Lock washer (17) and retaining screw (16). Install new impeller housing gasket (15) and then install rotating assembly. Draw bolts tight and check impeller clearance (.010-.020 normal), if clearance exceeds .020 remove a gasket, if clearance is less than .010 or if pump is locked-up add gaskets until proper clearance is achieved.
